[Docket No. FAA-2013-0695; Directorate Identifier 2011-NM-264-AD]

Airworthiness Directives; Saab AB, Saab Aerosystems Airplanes

ACTION: Notice of proposed rulemaking (NPRM).

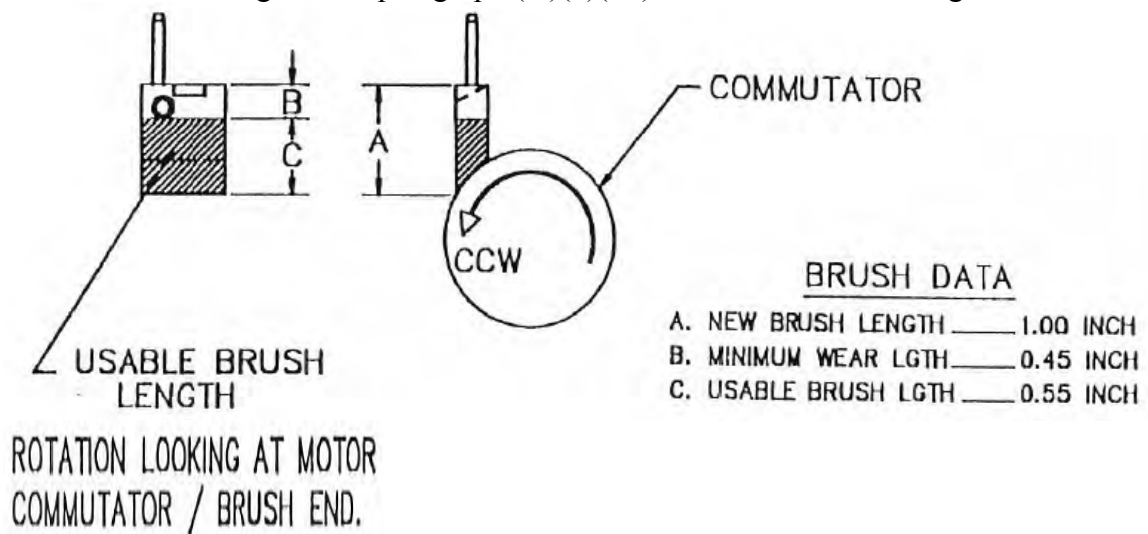
Figure 1 to paragraph (m)(2)(vii) of this AD – Measuring the Brush

- (ii) Remove all access panels and exhaust ducts to gain access to the drive motor.
- (iii) Disconnect power leads from motor terminals (1/4-28). Tag positive lead.
- (iv) Remove condenser support bracket to provide access to brush cover fasteners and remove motor cuff shroud.
- (v) Loosen and unsnap brush cover assembly. Remove from motor.
- (vi) With wire hook or scribe, lift brush spring and remove brush.
- (vii) Measure each brush as shown in figure below and record values.

- (viii) Using the brush with the shortest measured length calculate the wear by subtracting the measured value from 1.000 inch.
- (ix) Replace brushes in accordance with the instructions specified in paragraphs (j)(9) through (j)(23) of this AD.

(11) Install each new brush set by lifting brush springs, sliding brush into holder (with brush leading edge in direction of motor rotation) and lightly releasing the brush spring on the brush. (See Figure 1 to paragraph (m)(2)(vii) of this AD). CAUTION: Do not allow brush spring to strike hard into place or damage to brush may result.
